**TMI-2 RCS MANWAY COVER BACKING PLATES
SURFACE DEPOSIT EXAMINATIONS**

September 1987

**Battelle Columbus Division
505 King Avenue
Columbus, Ohio 43201**

**Prepared for EG&G Idaho, Inc.
Under Subcontract No. C86-130969
and the U.S. Department of Energy
Three Mile Island Operations Office
Under DOE Contract No. DE-AC07-76ID001570**

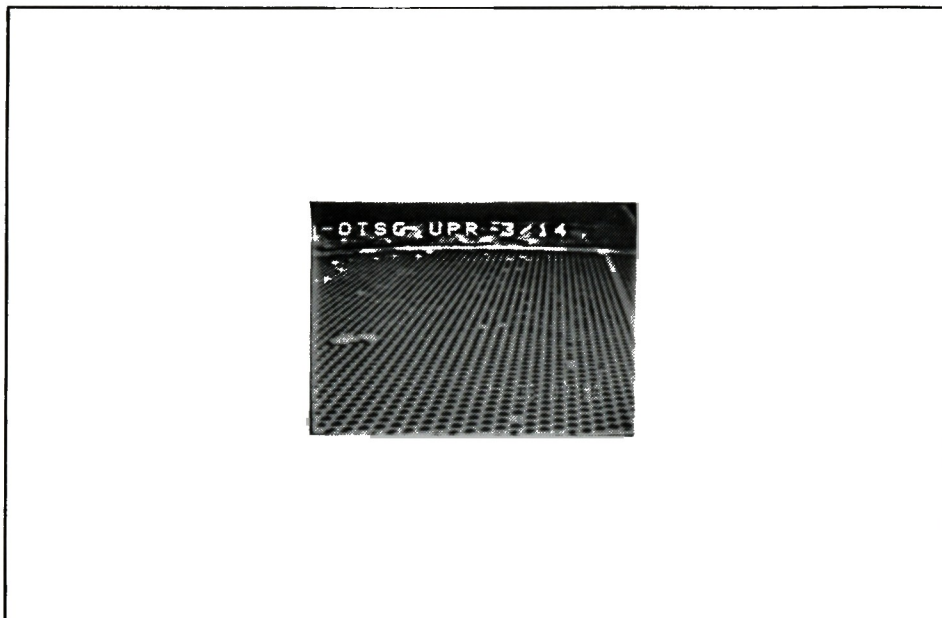
A-loop steam generator tube sheet top

B-loop steam generator tube sheet top

Figure 4. Video still-image views of TMI-2 steam generator tube sheet tops in March 1986.

- boron: 5000 to 5350 ppm
 - buffer: NaOH
- The RCS liquid volume was drawn down for initial reactor disassembly in July 1982, uncovering the pressurizer and steam generator upper regions. Figure 4 shows video still-images of the conditions at the top of the steam generator tube sheet when the manway covers were removed in March 1986.

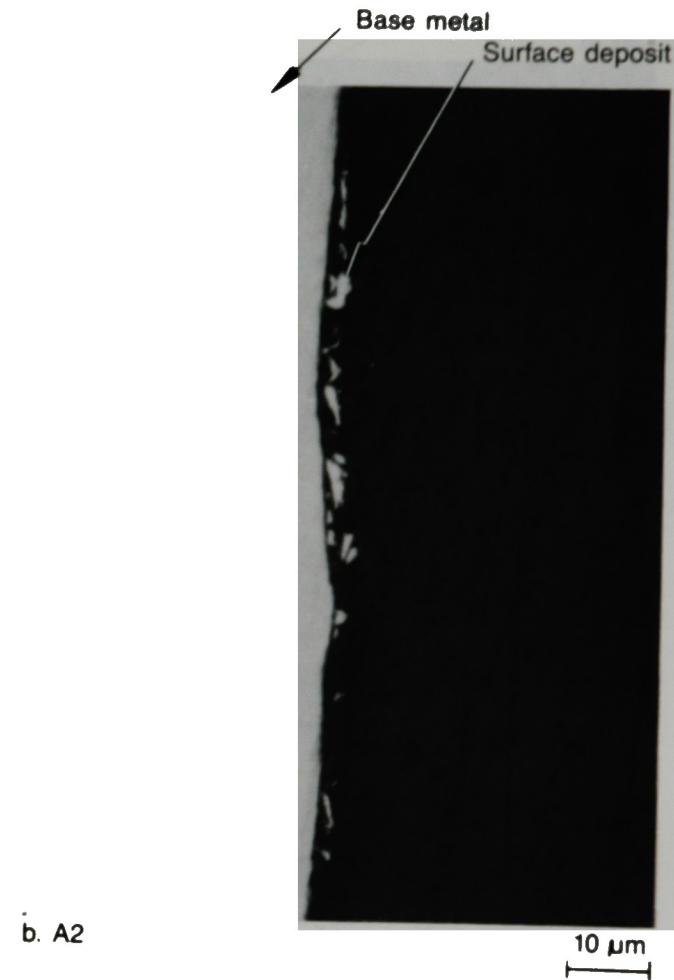
Figure 20a and b. Optical micrographs of specimens from plate A.

Figure 20c and d. Optical micrographs of specimens from plate A.

- Metallographic examination of the plate samples showed the thickness of the surface deposits varied from 4-12 μm (Plates B and P) to 2-4 μm (Plate A). The deposits consisted mainly of Fe, Cr, and Ni, although evidence of In and Sn was also found.

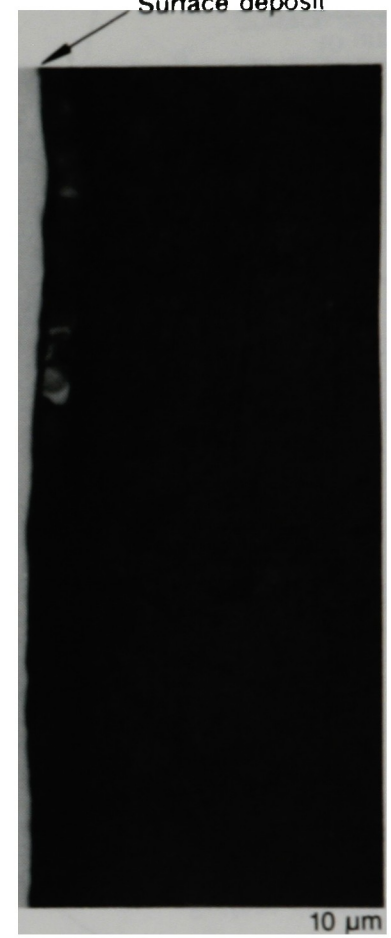
Base metal

Surface deposit

a. B1

b. B2

Figure 21a and b. Optical micrographs of specimens from plate B.

Figure 21c and d. Optical micrographs of specimens from plate B.
